**FATIGUE RESPONSE OF REPAIRED
THICK ALUMINUM PANELS WITH
BONDLINE FLAWS**

Presented to the Faculty of the Graduate School of Engineering of the Air Force Institute of
Technology Air University In Partial Fulfillment for the Degree of

Sponsored by both the Fatigue and Fracture Group, Air Vehicle's Directorate (AFRL/VASE)
and the Mission Support Group, Material's Directorate (AFRL/MLSA)..

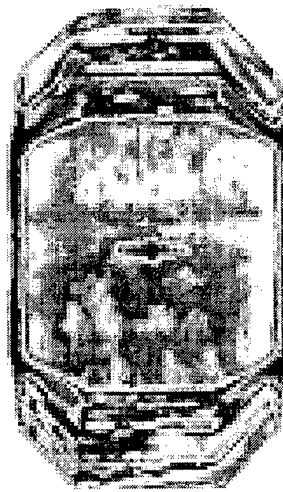
Figure 66. C-scan Fully Bonded Patch (FBP) $2a=25.4\text{mm}$

This appendix contains select C-scan images of specimens detailing disbond size as a function of crack length.. A representative of each disbond configuration is presented. Three images from each disbond configuration are included. Tthe first image shows debond size and location at $2a = 25.4mm$, the second at $2a = 63.5mm$ and the third at $2a = 101.6mm$.

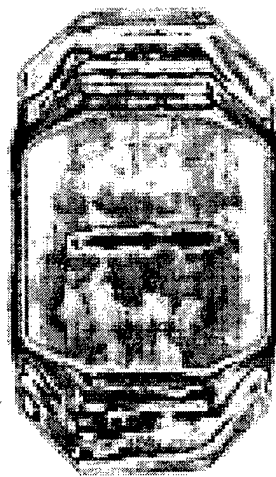
Figure 67. C-scan Fully Bonded Patch (FBP) $2a=63.5\text{mm}$

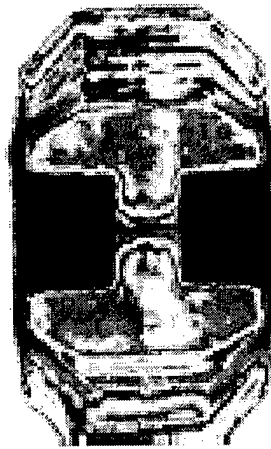
Figure 74. C-scan Crack Tip Disbond (CTD) $2a=101.6\text{mm}$
